LIVESTOCK INSPECTION DIGITAL PHOTOGRAPH PHOTOCOPIES

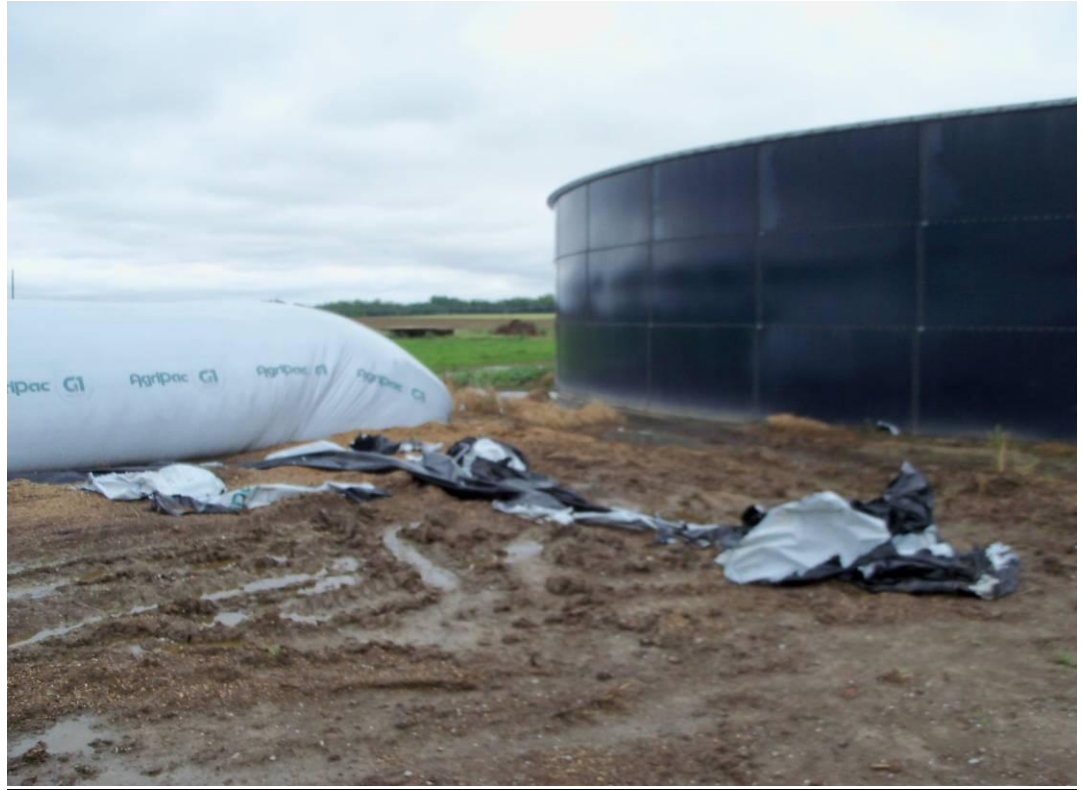
Photo # 001
Date: May 26, 2011
Time: 12:32 p.m.
Taken By: Brian Rodely DWPC/FOS
Facility: Elm Farms, Inc.
Location: S edge of silage storage
Notes: This is a photograph of the southern edge of the facility's silage storage area. Runoff from the area flow around the northeast corner of the Slurrystore.

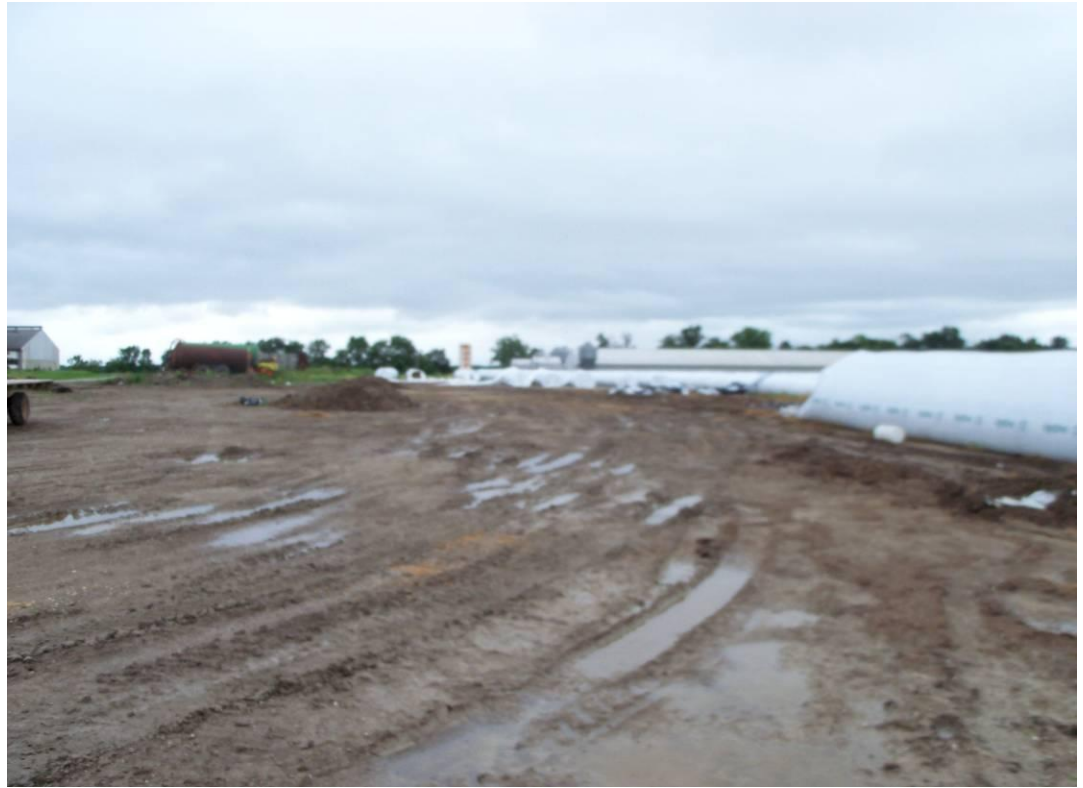
Photo # 002
Date: May 26, 2011
Time: 12:32 p.m.
Taken By: Brian Rodely DWPC/FOS
Facility: Elm Farms, Inc.
Location: S edge of silage storage
Notes: This is a photograph of the facility's silage storage area. Note some of the old silage on the ground surface.

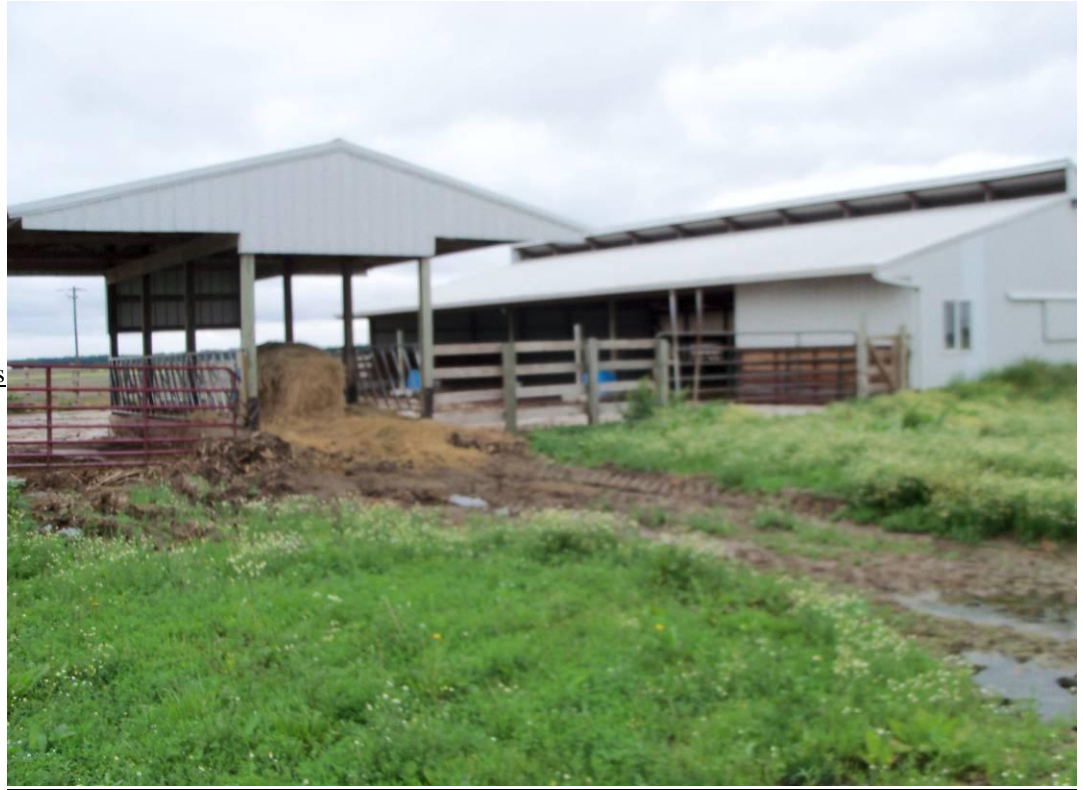
Photo # 003
Date: May 26, 2011
Time: 12:39 p.m.
Taken By: Brian Rodely DWPC/FOS
Facility: Elm Farms, Inc.
Location: NW portion of dairy
Notes: This is a photograph of one of the concrete feedlot areas. There were no livestock on the feedlot at the time of the visit. Concrete feedlot runoff was not tributary to a manure storage structure and note that some of the feed is exposed. Also, note that the adjacent buildings are not equipped with guttering.

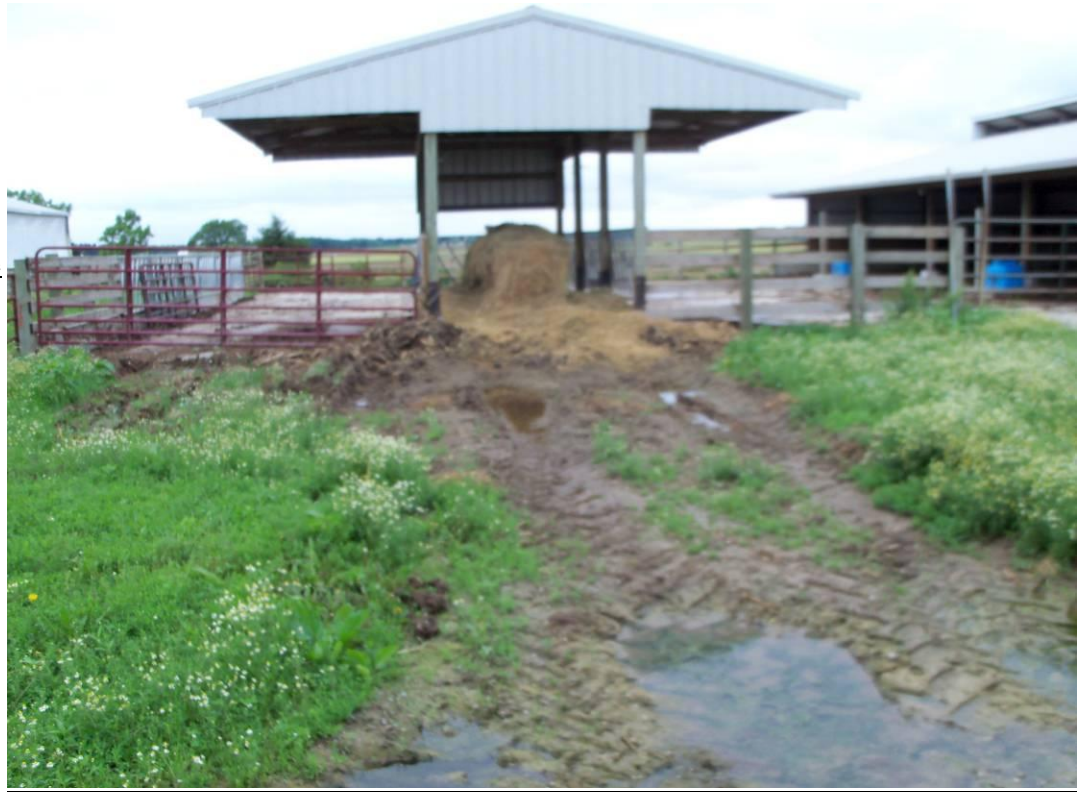
Photo # 004
Date: May 26, 2011
Time: 12:39 p.m.
Taken By: Brian Rodely DWPC/FOS
Facility: Elm Farms, Inc.
Location: NW portion of dairy
Notes: This is a close-up photo of vacant feedlot. Again, note the partially exposed feed.

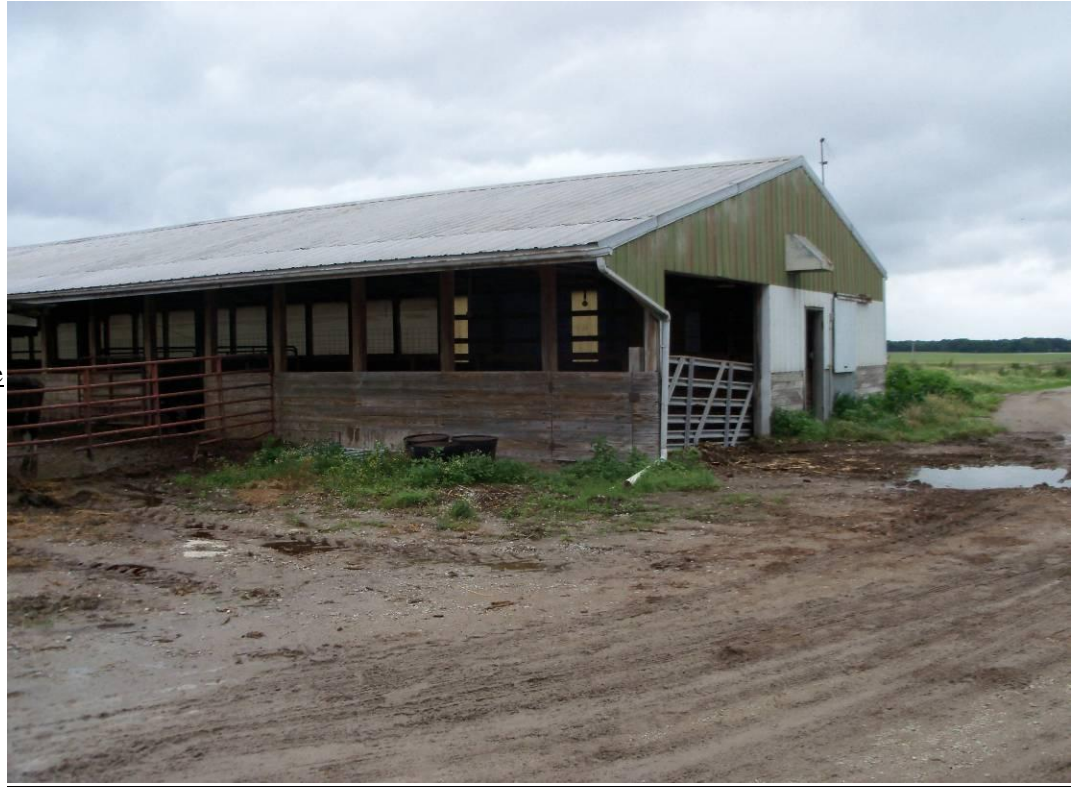
Photo # 005
Date: May 26, 2011
Time: 12:40 p.m.
Taken By: Brian Rodely DWPC/FOS
Facility: Elm Farms, Inc.
Location: NW portion of dairy
Notes: This is a photograph of one of the facility's loafing sheds. Note that used bedding is exiting the barn and being exposed. The runoff is not tributary to the holding pond system.

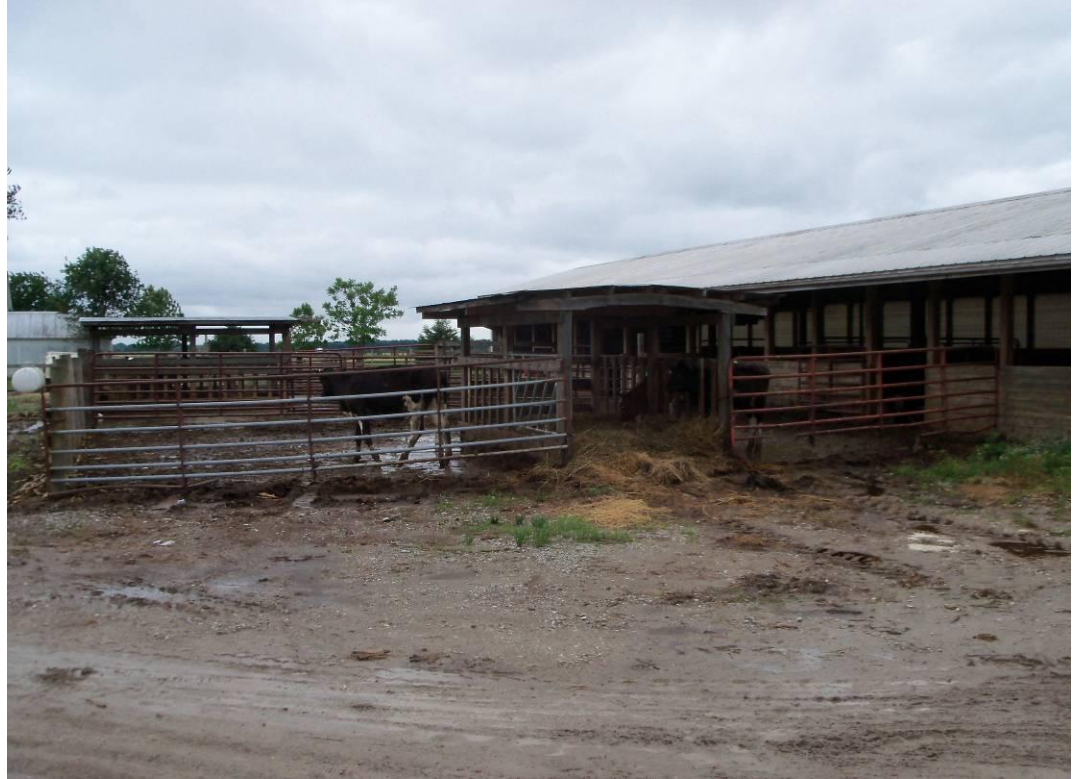
Photo # 006
Date: May 26, 2011
Time: 12:40 p.m.
Taken By: Brian Rodely DWPC/FOS
Facility: Elm Farms, Inc.
Location: W portion of dairy facility
Notes: This is a photo of a small feedlot area. Runoff enters an access line and is not tributary to the waste holding pond system.

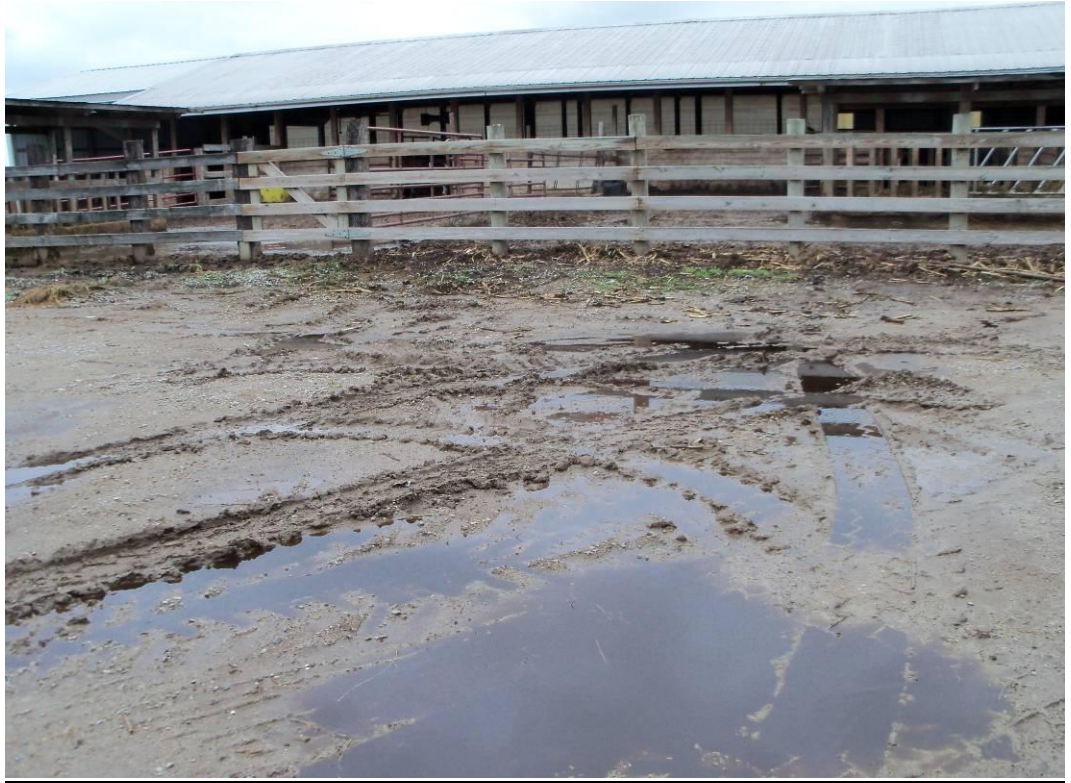
Photo # 007
Date: May 26, 2011
Time: 12:40 p.m.
Taken By: Brian Rodely DWPC/FOS
Facility: Elm Farms, Inc.
Location: NW portion of dairy
Notes: This is a photograph of another loafing shed and feedlot area. There was no containment for manure runoff. Runoff flows onto the access lane. Note the dark colored liquid on the access lane.

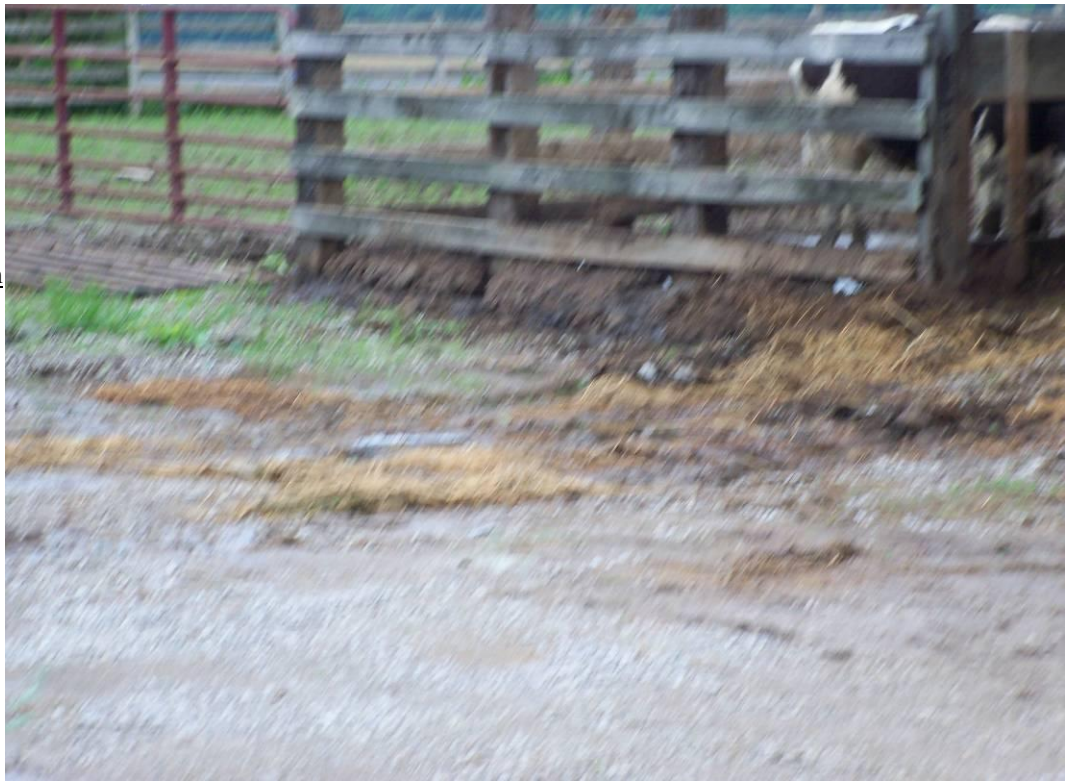
Photo # 008
Date: May 26, 2011
Time: 12:40 p.m.
Taken By: Brian Rodely DWPC/FOS
Facility: Elm Farms, Inc.
Location: NW portion of dairy
Notes: This is a close-up photo of a feedlot area. Runoff from the lot flows onto the access lane. Note the manure solids and used bedding on the lane.

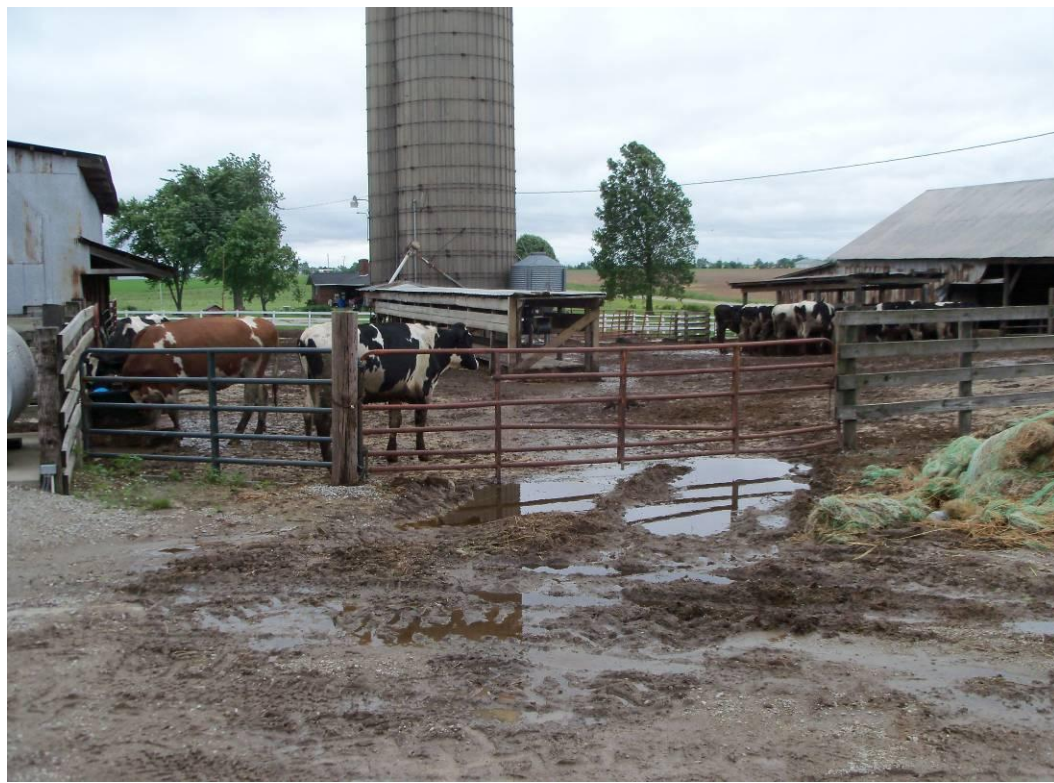
Photo # 009
Date: May 26, 2011
Time: 12:42 p.m.
Taken By: Brian Rodely DWPC/FOS
Facility: Elm Farms, Inc.
Location: NW portion of dairy
Notes: facility
This is a photograph of
another feedlot area.
Runoff from the feedlot
flows onto the access lane
and is not tributary to the
holding pond system.

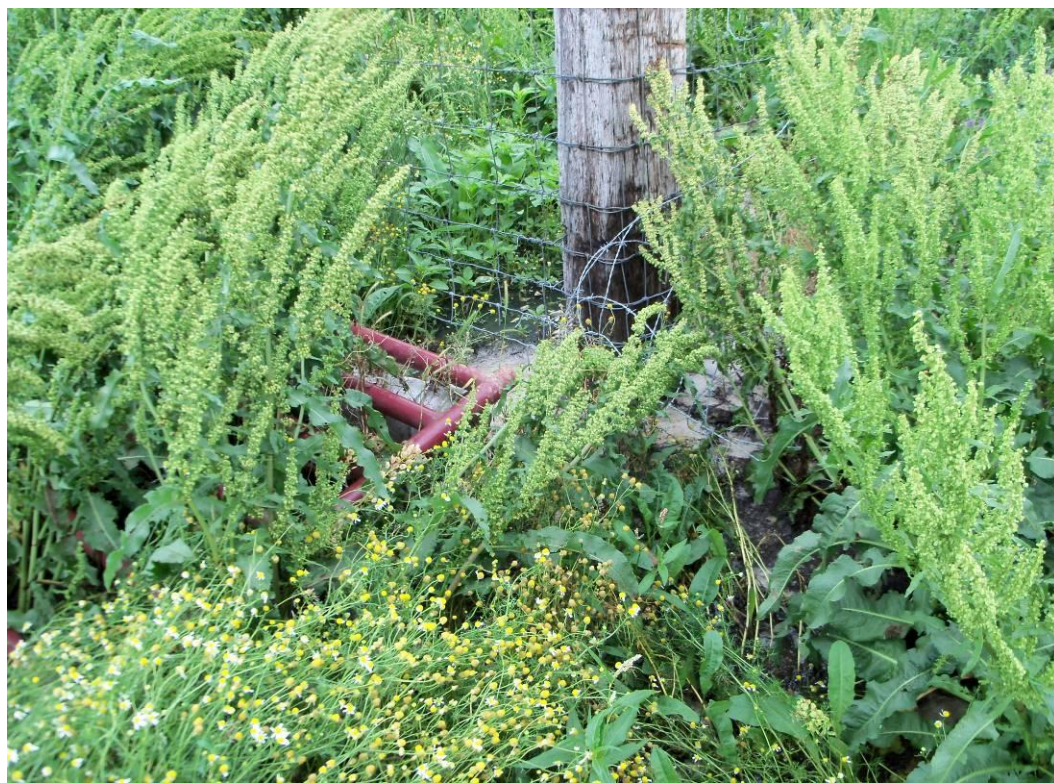
Photo # 010
Date: May 26, 2011
Time: 12:54 p.m.
Taken By: Brian Rodely DWPC/FOS
Facility: Elm Farms, Inc.
Location: SW of holding ponds
Notes: This is a close-up photo of
the overflow from the
dairy's first stage holding
pond.

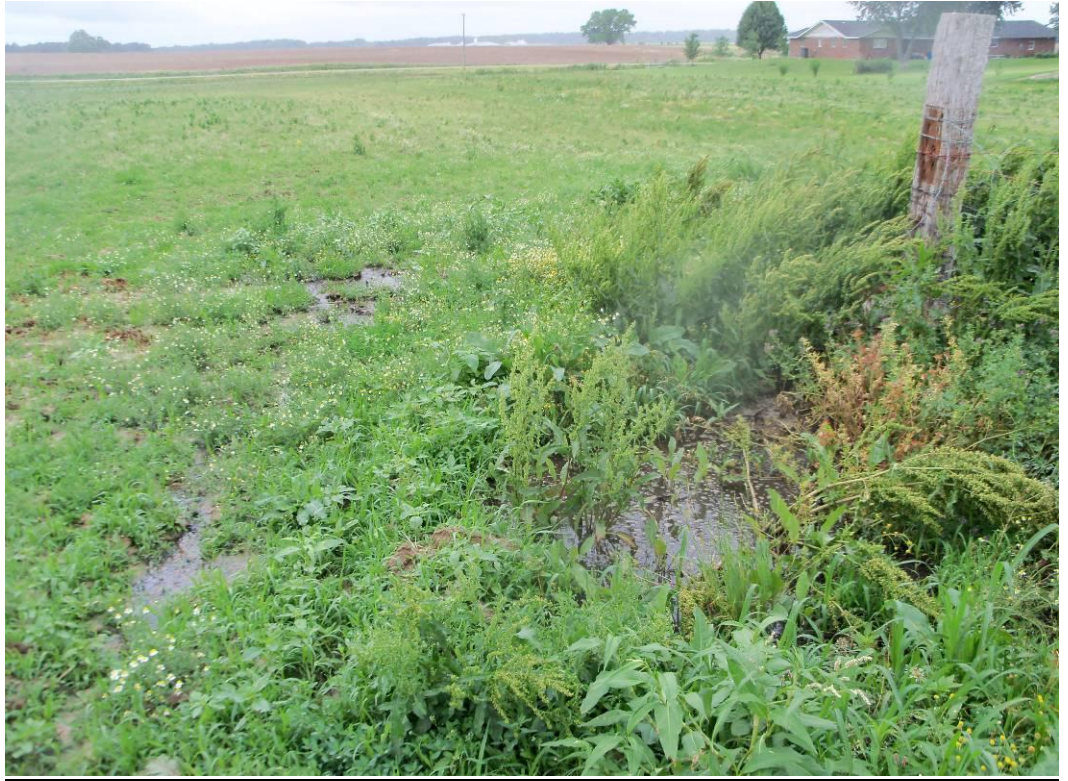
Photo # 011
Date: May 26, 2011
Time: 12:54 p.m.
Taken By: Brian Rodely DWPC/FOS
Facility: Elm Farms, Inc.
Location: SW of holding ponds
Notes: This is a photograph of the first stage holding pond's discharge as it flows down the exterior berm.

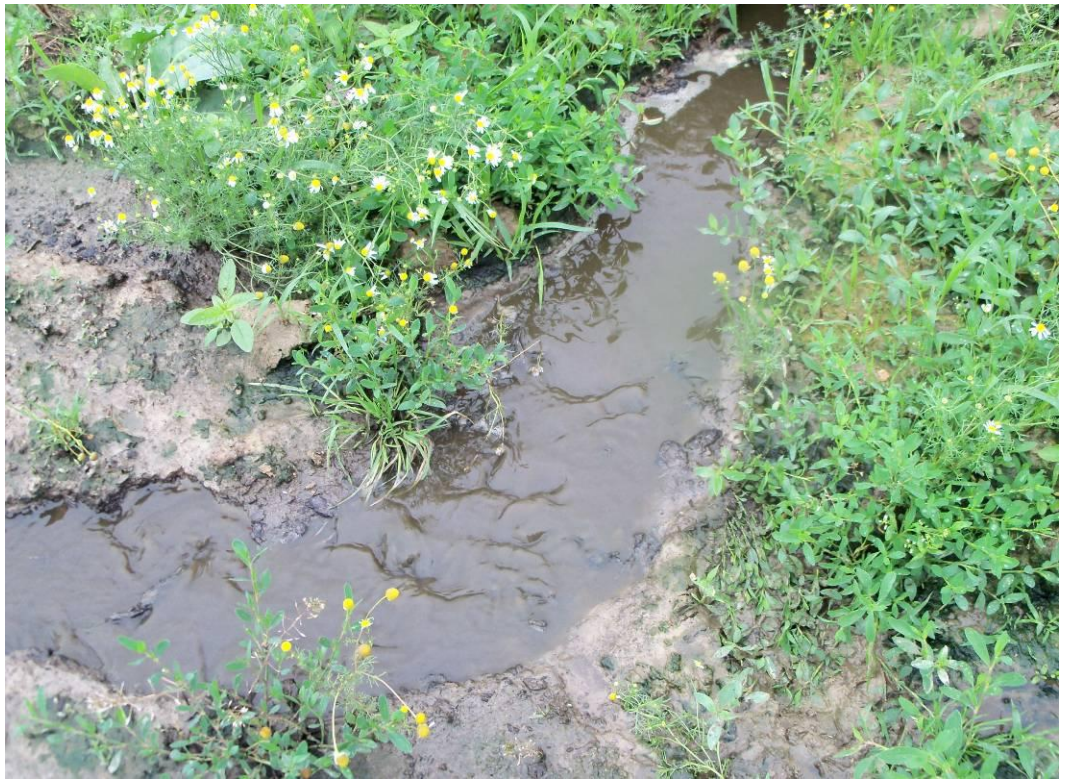
Photo # 012
Date: May 26, 2011
Time: 12:54 p.m.
Taken By: Brian Rodely DWPC/FOS
Facility: Elm Farms, Inc.
Location: SW of holding ponds
Notes: This is a close-up photo of the first stage holding pond discharge. Note the dark color of the liquid.

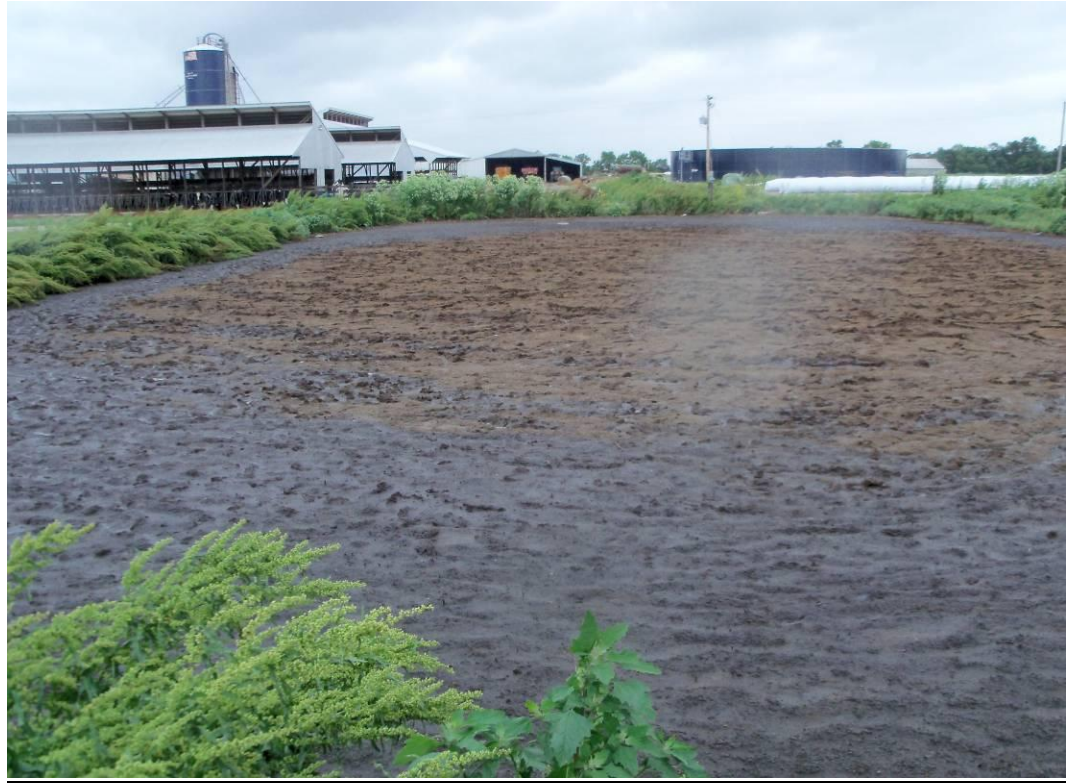
Photo # 013
Date: May 26, 2011
Time: 12:55 p.m.
Taken By: Brian Rodely DWPC/FOS
Facility: Elm Farms, Inc.
Location: S of the 1st stage pond
Notes: This is a photograph of the dairy's first stage holding pond. Note that the pond has no available freeboard. Also, note the dense vegetation on the exterior berms.

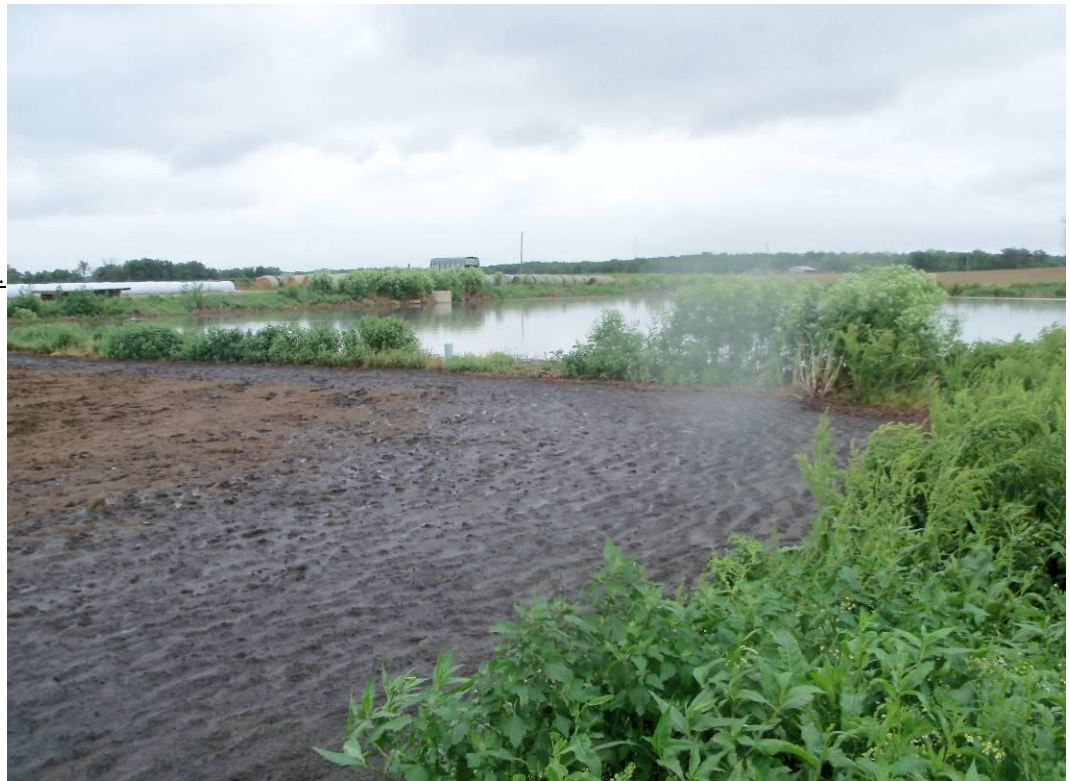
Photo # 014
Date: May 26, 2011
Time: 12:55 p.m.
Taken By: Brian Rodely DWPC/FOS
Facility: Elm Farms, Inc.
Location: SE corner of 1st stage pond
Notes: This is a close-up photo of the first stage holding pond. Again, note the dense vegetation on the exterior berms.

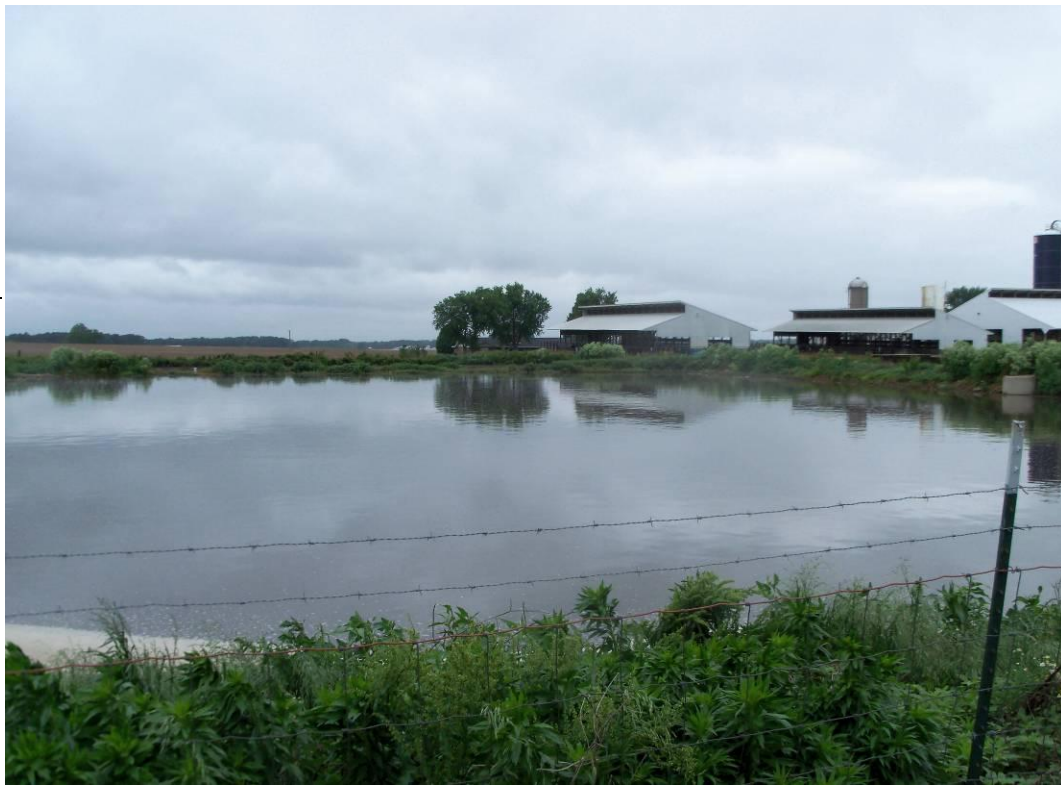
Photo # 015
Date: May 26, 2011
Time: 1:00 p.m.
Taken By: Brian Rodely DWPC/FOS
Facility: Elm Farms, Inc.
Location: E of 2nd stage pond
Notes: This is a photograph of the
second stage ponding pond.

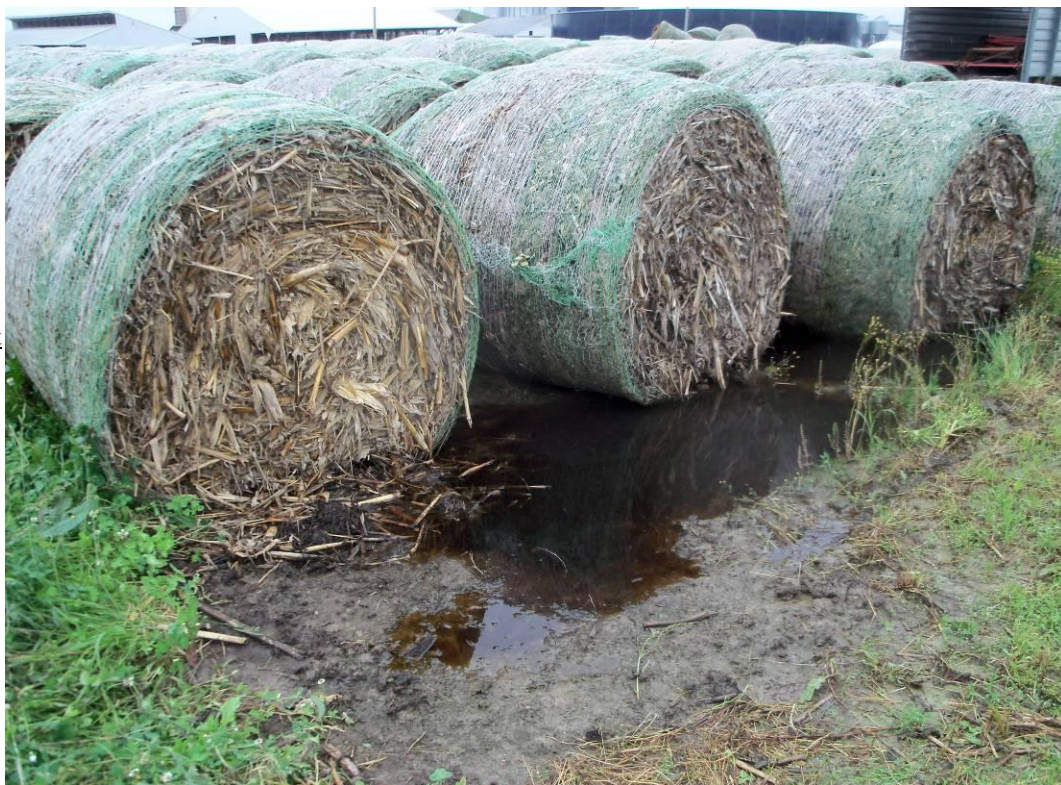
Photo # 016
Date: May 26, 2011
Time: 1:13 p.m.
Taken By: Brian Rodely DWPC/FOS
Facility: Elm Farms, Inc.
Location: E of the baled storage area
Notes: This is a photo of baled
corn stalk storage area.
Note the significant amount
of leachate pooled around
the storage area.

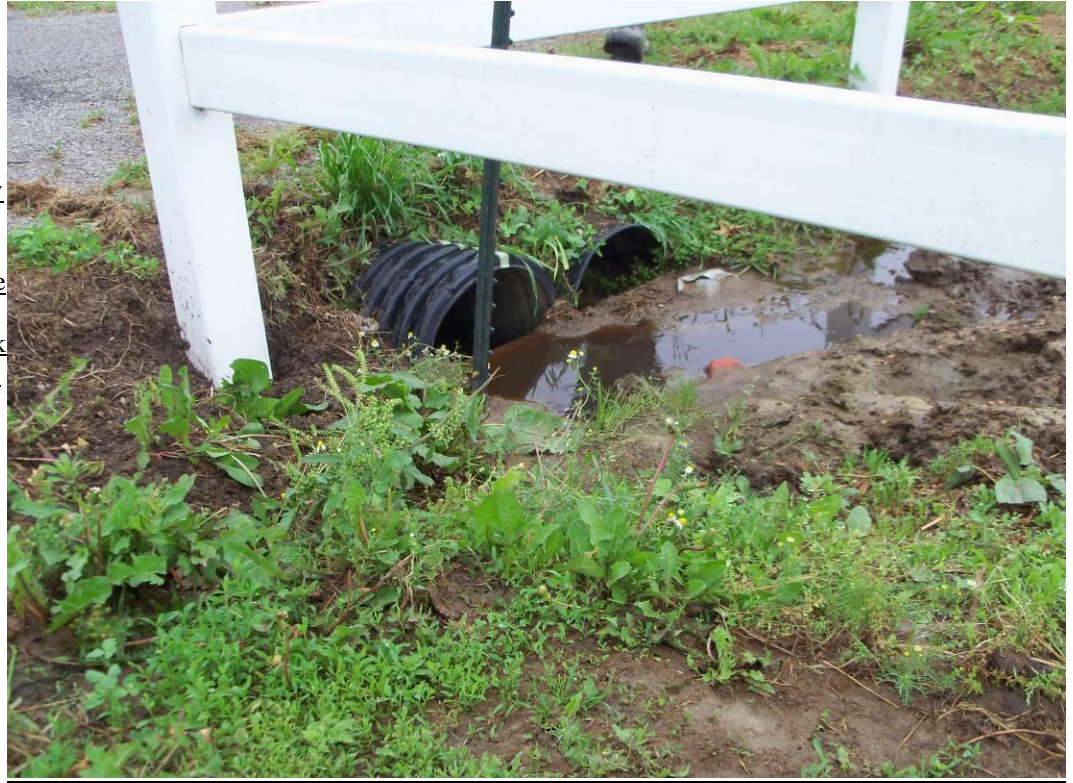
Photo # 017
Date: May 26, 2011
Time: 1:45 p.m.
Taken By: Brian Rodely DWPC/FOS
Facility: Elm Farms, Inc.
Location: SW portion of dairy facility
Notes: This is a photograph of
drainage tile which carries
earthen feedlot runoff to the
culvert under Bottom
Prairie Road. Note the dark
liquid entering the drainage
tile.

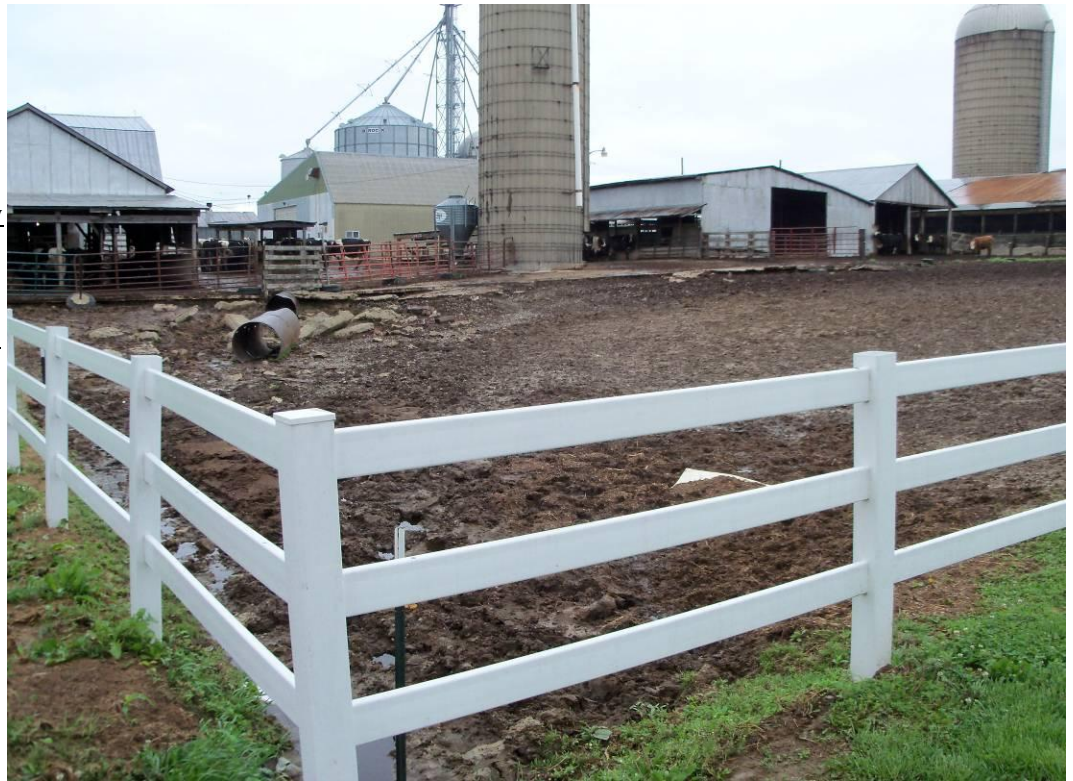
Photo # 018
Date: May 26, 2011
Time: 1:45 p.m.
Taken By: Brian Rodely DWPC/FOS
Facility: Elm Farms, Inc.
Location: SW portion of dairy facility
Notes: This is a photograph of the
feedlot area that discharges
through the two field tiles
in the previous photograph.

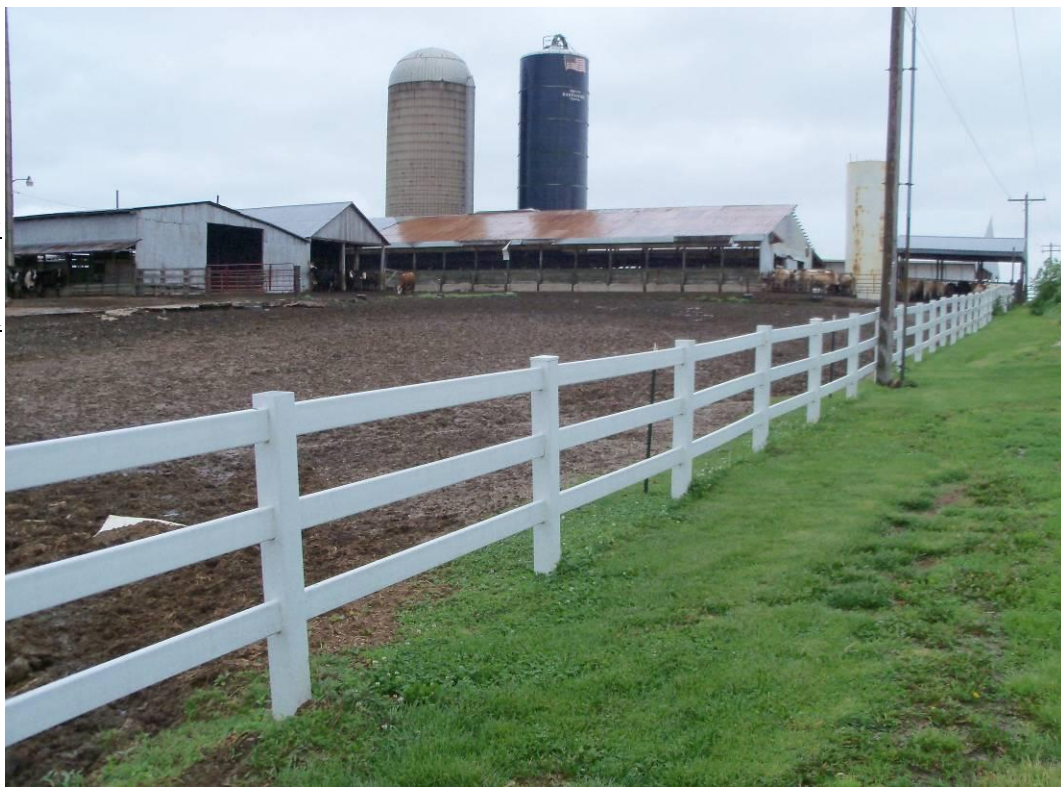
Photo # 019
Date: May 26, 2011
Time: 1:45 p.m.
Taken By: Brian Rodely DWPC/FOS
Facility: Elm Farms, Inc.
Location: SW portion of dairy facility
Notes: This is another photograph
of the earthen feedlot that
discharges through the field
tiles.

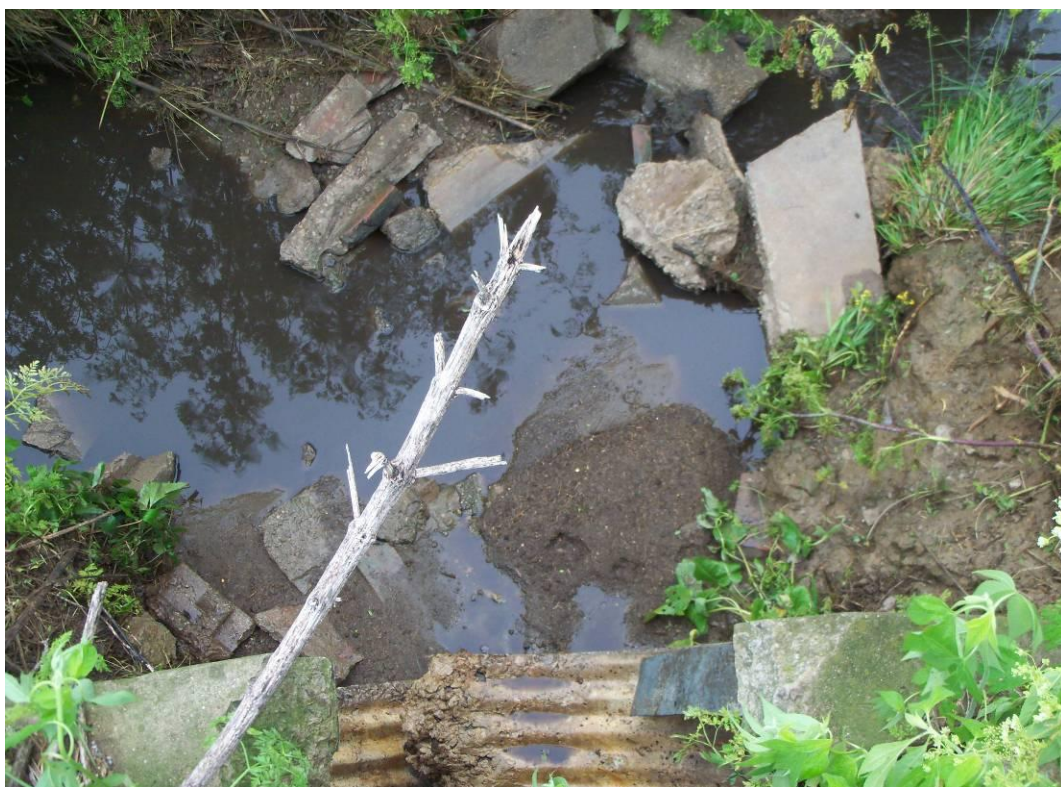
Photo # 020
Date: May 26, 2011
Time: 1:49 p.m.
Taken By: Brian Rodely DWPC/FOS
Facility: Elm Farms, Inc.
Location: W of Bottom Prairie Rd.
Notes: This is a photo of west side
of Bottom Prairie road
adjacent to the culvert
which carries runoff
through the field tiles.
Note the dark appearance
of the liquid.

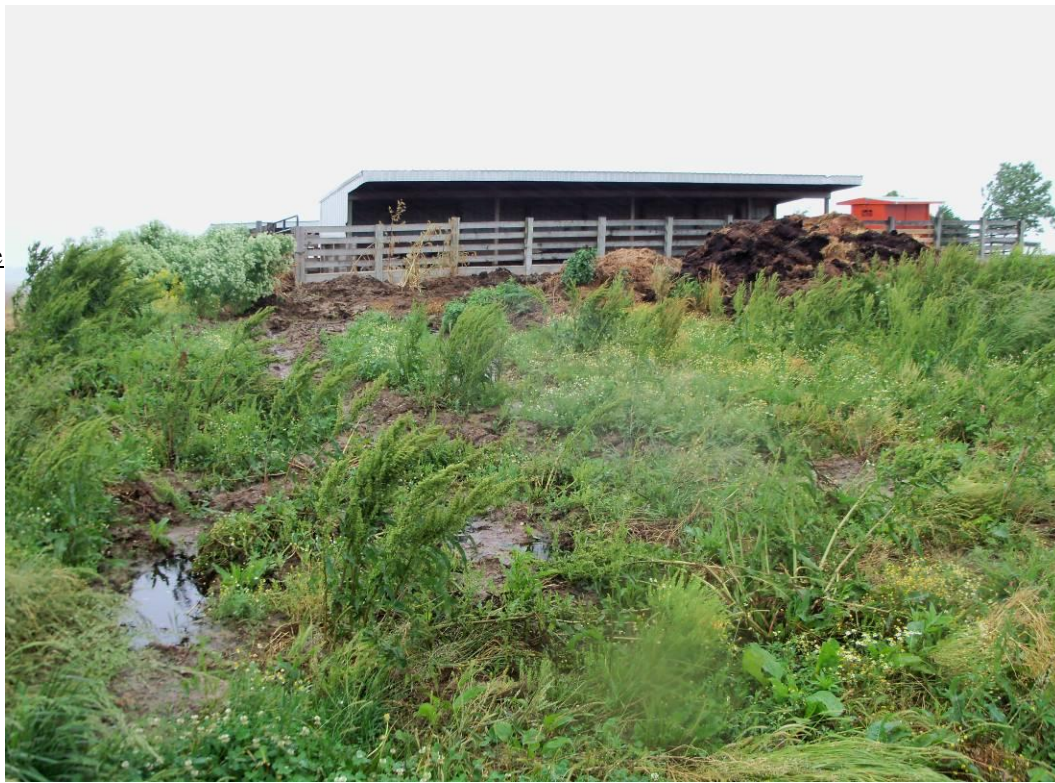
Photo # 021
Date: May 26, 2011
Time: 1:59 p.m.
Taken By: Brian Rodely DWPC/FOS
Facility: Elm Farms, Inc.
Location: W of Bottom Prairie Rd.
Notes: This is a photograph of the manure stacking area. Note the dark colored leachate exiting the stacking area.

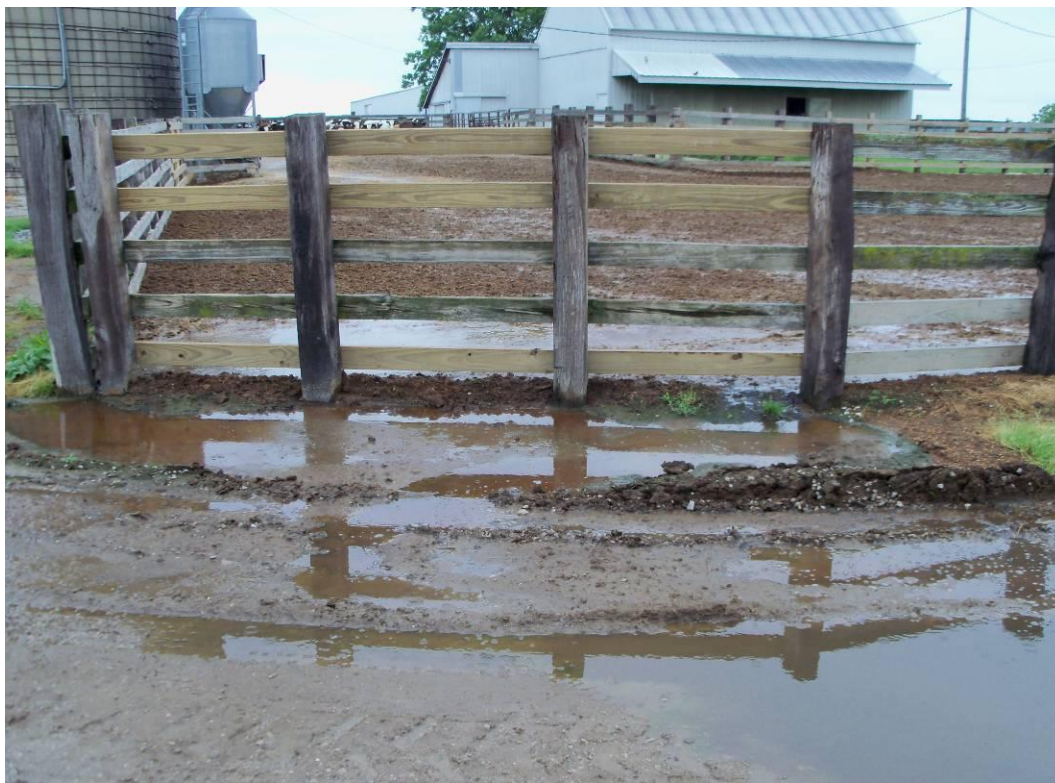
Photo # 022
Date: May 26, 2011
Time: 2:53 p.m.
Taken By: Brian Rodely DWPC/FOS
Facility: Elm Farms, Inc.
Location: SW of beef feedlot area
Notes: This is a photo of feedlot area for the beef operation. Note the runoff exiting the feedlot area.

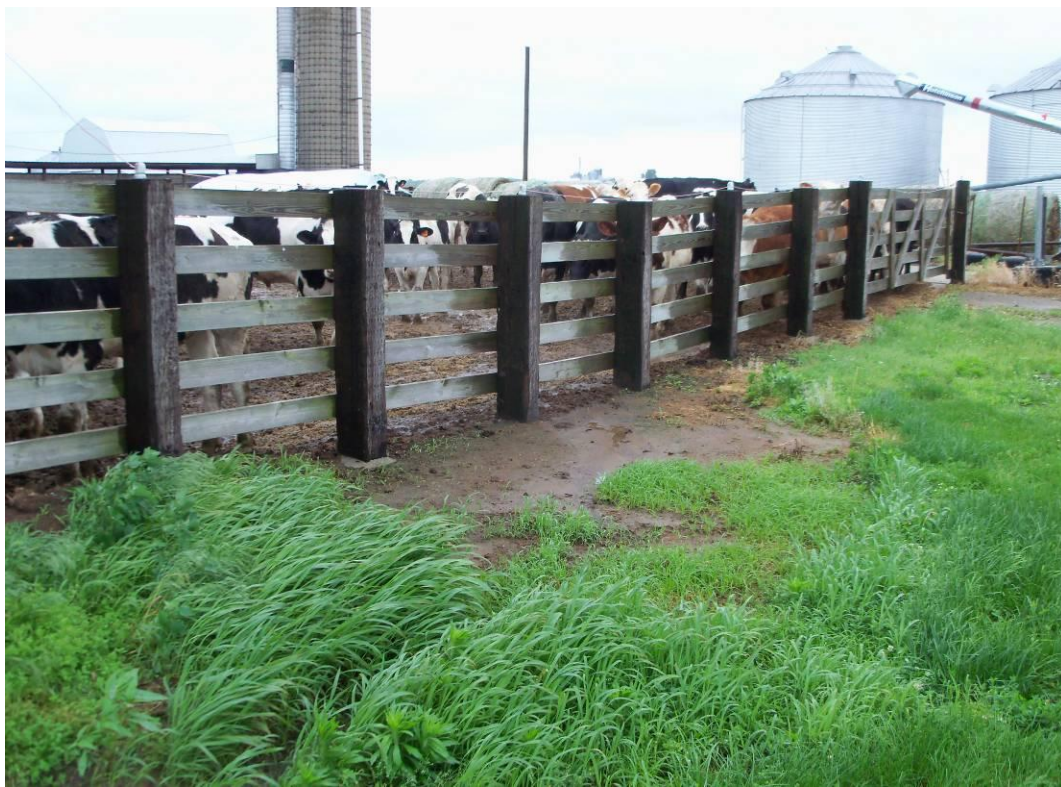
Photo # 023
Date: May 26, 2011
Time: 2:57 p.m.
Taken By: Brian Rodely DWPC/FOS
Facility: Elm Farms, Inc.
Location: W of beef feedlot
Notes: This is a photo of the west side of the beef operation's feedlot area. Note the uncontrolled runoff exiting the west side of the feedlot area.

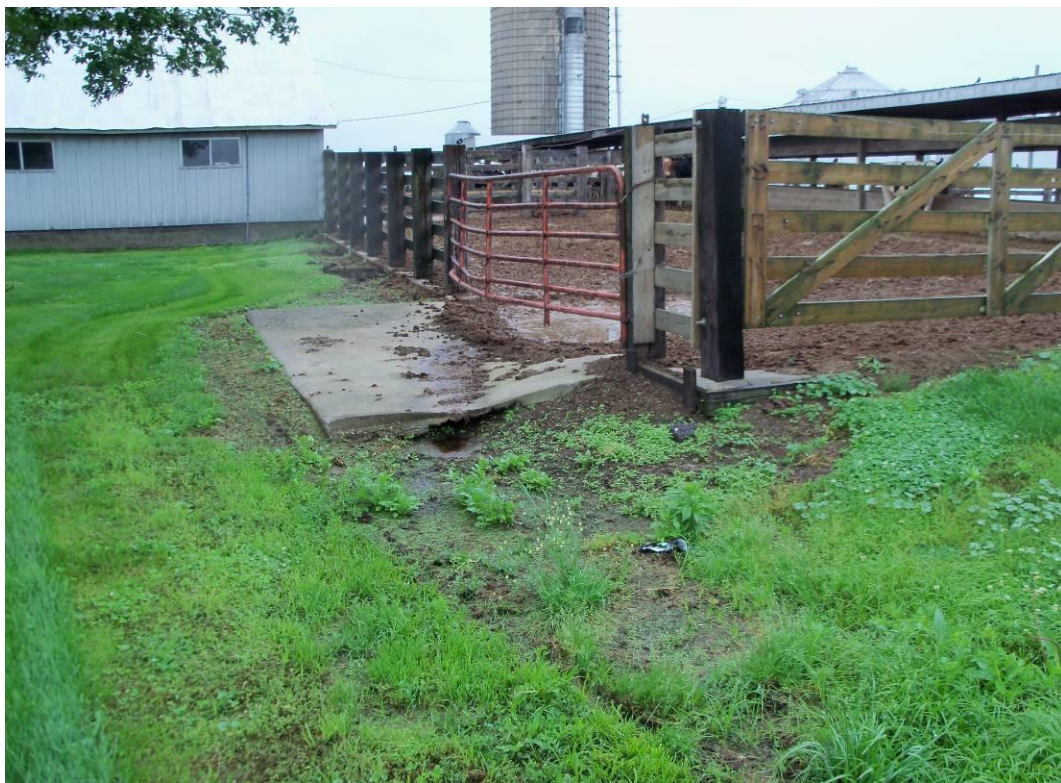
Photo # 024
Date: May 26, 2011
Time: 3:03 p.m.
Taken By: Brian Rodely DWPC/FOS
Facility: Elm Farms, Inc.
Location: NE of beef feedlot
Notes: This is a photo of the northeast side of the beef feedlot area. Note the runoff exiting the feedlot area.

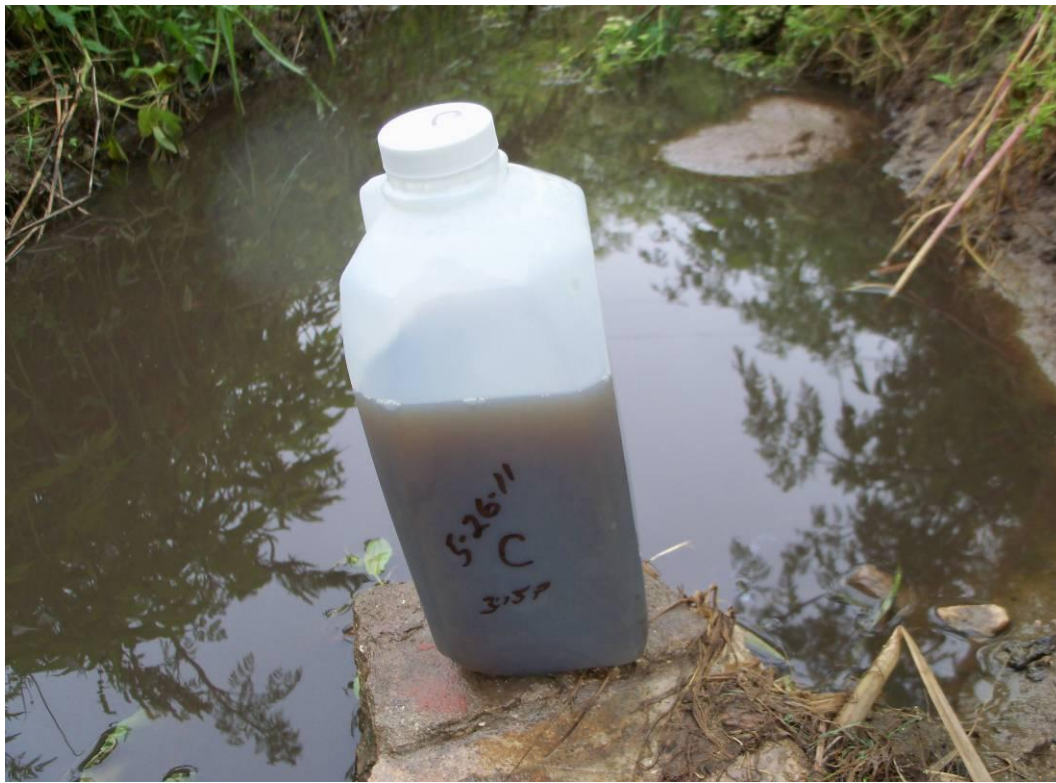
Photo # 025
Date: May 26, 2011
Time: 3:21 p.m.
Taken By: Brian Rodely DWPC/FOS
Facility: Elm Farms, Inc.
Location: W of Bottom Prairie Rd
Notes: This is a photograph of the location where sample C was collected. Note the dark appearance of the sample.
